U.S. DOE FUNDED FIELD TEST OF DHR SYSTEM Case Study: Hair Salon, Sayville, NY

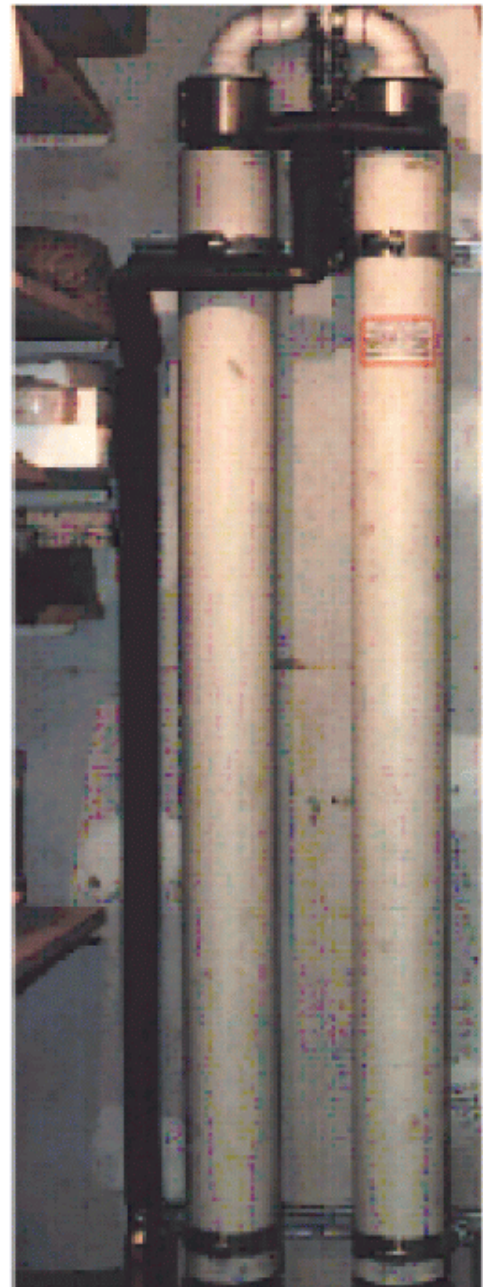
***GFX Model P3-60
Prototype Shown
Mounted On Utility
Room Wall In N.Y.
Hair Salon***

Hartell Model LTP-L, Laundry Tray Pump sized for 3 sinks having 3.5 gpm sprayers; One P3-60 prototype installed with PVC manifold; Shop manager had previously removed all filters from sinks, so a Grainger, Teal Model 1P999 Basket Strainer had to be installed to protect the pump; Strainer was emptied every few weeks. (Daily cleaning was not necessary because hair floats.)
